Albany County, Altamont, Altamont Historic
District (Guilderland MRA), Main Street
between Thacher Dr. and the RR Station.

**National Register of Historic Places
Inventory—Nomination Form**

Historic Resources of Guilderland, Albany Co., NY

Altamont Historic District,

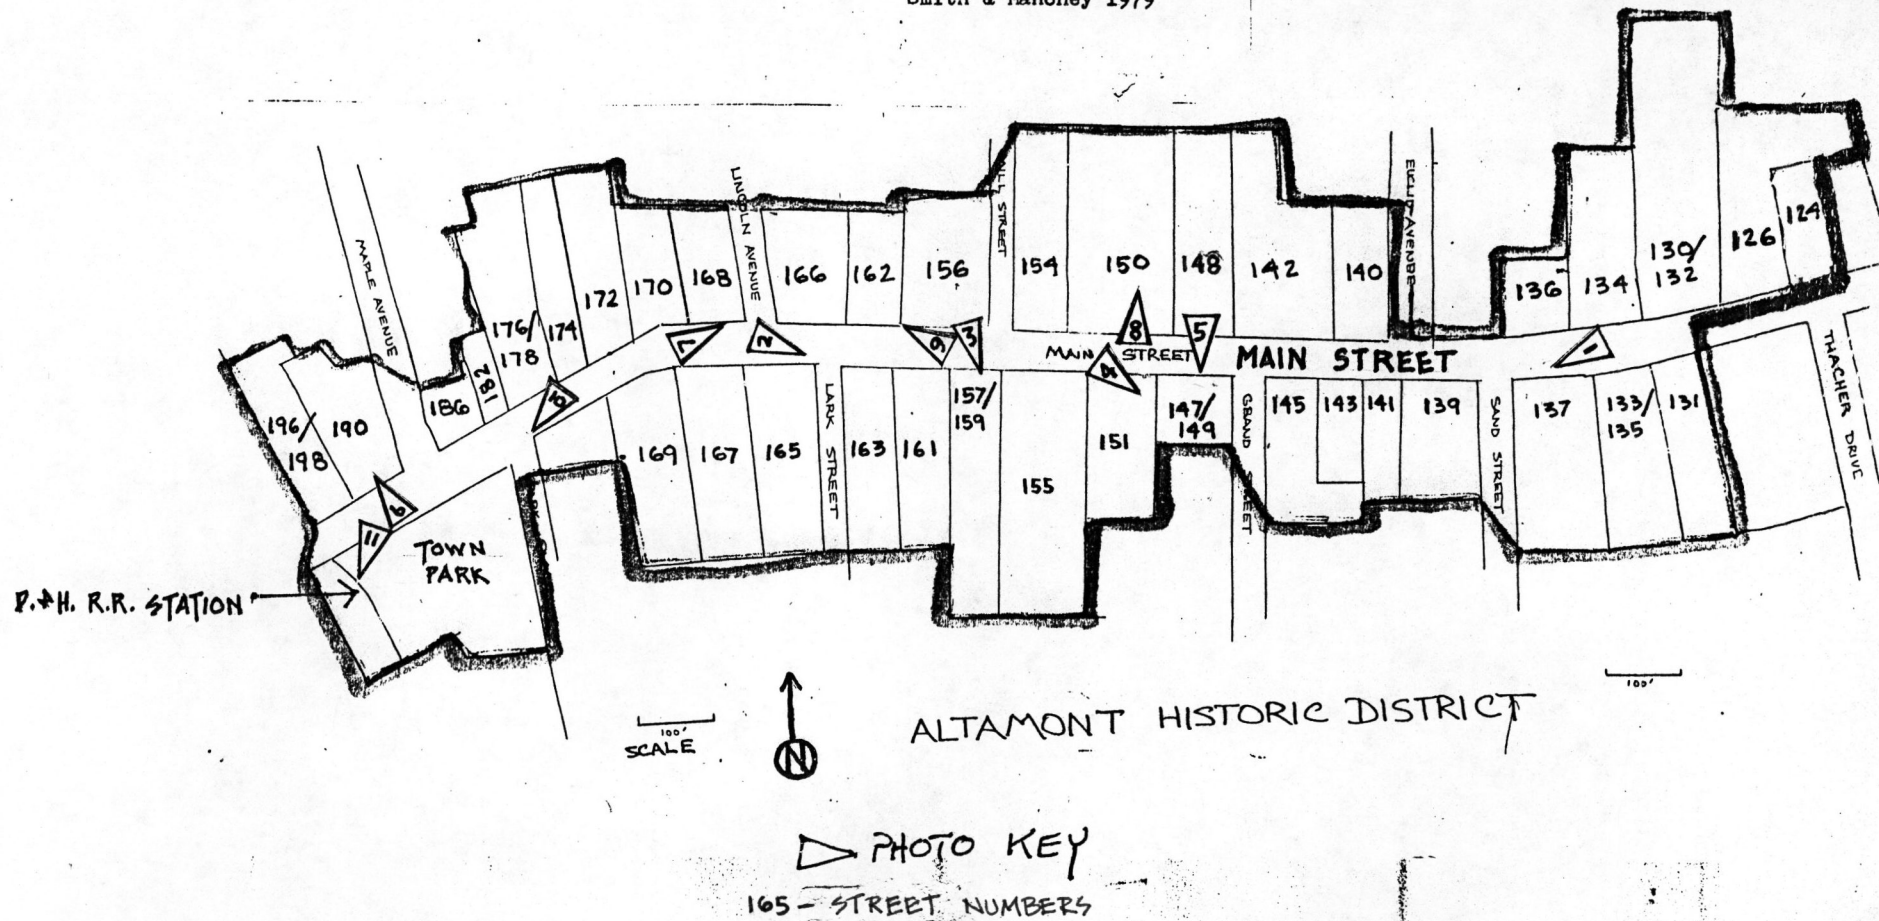
Historic Resources of
 Guilderland Phase I
 Albany County Guilderland
 New York
 Site Map (from tax map)
 Smith & Mahoney 1979

See tax maps for individual properties (attached to Building/Structure Inventory forms)

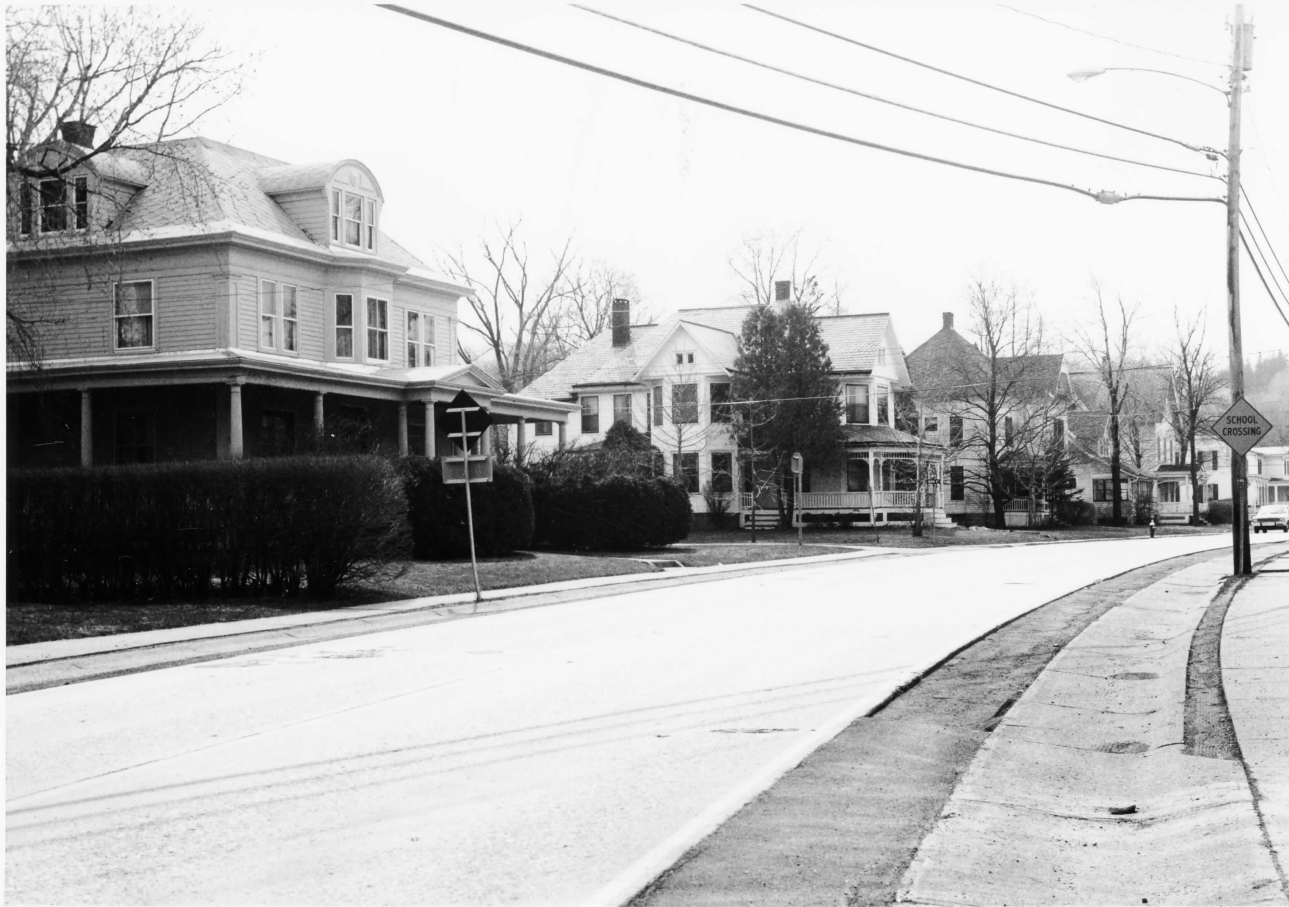
1.

View: 137-145 Main Street
South side
Looking west

| <u>Street</u> | <u>Date</u> | <u>Description</u> | <u>Photo</u> | <u>Statewide Inv.</u> <u>No.</u> |
|---|---|---|---|---|
| 139 Main St. | c.1890 | Two and one-half stories, Queen Anne Style design, Multi-gabled roof, wood frame, projecting bays, one-story porch on front with turned posts and spindle decoration, asbestos siding. | 1 | 001-45-0042 26 |
| 141 Main St. | c.1895 | Two and one-half stories, hipped roof with gable projection on front, wood frame with clapboard siding, wide paneled frieze and plain channeled cornice, decoration in gable end, one-story porch on front. | 1 | 001-45-0041 27 |
| 143 Main St. | 1926 | Two stories, wood frame, gable roof with flared eaves, Bungalow Style design, dormer window, one-story porch on front, grouped windows. | 1 | 001-45-0040 28 |

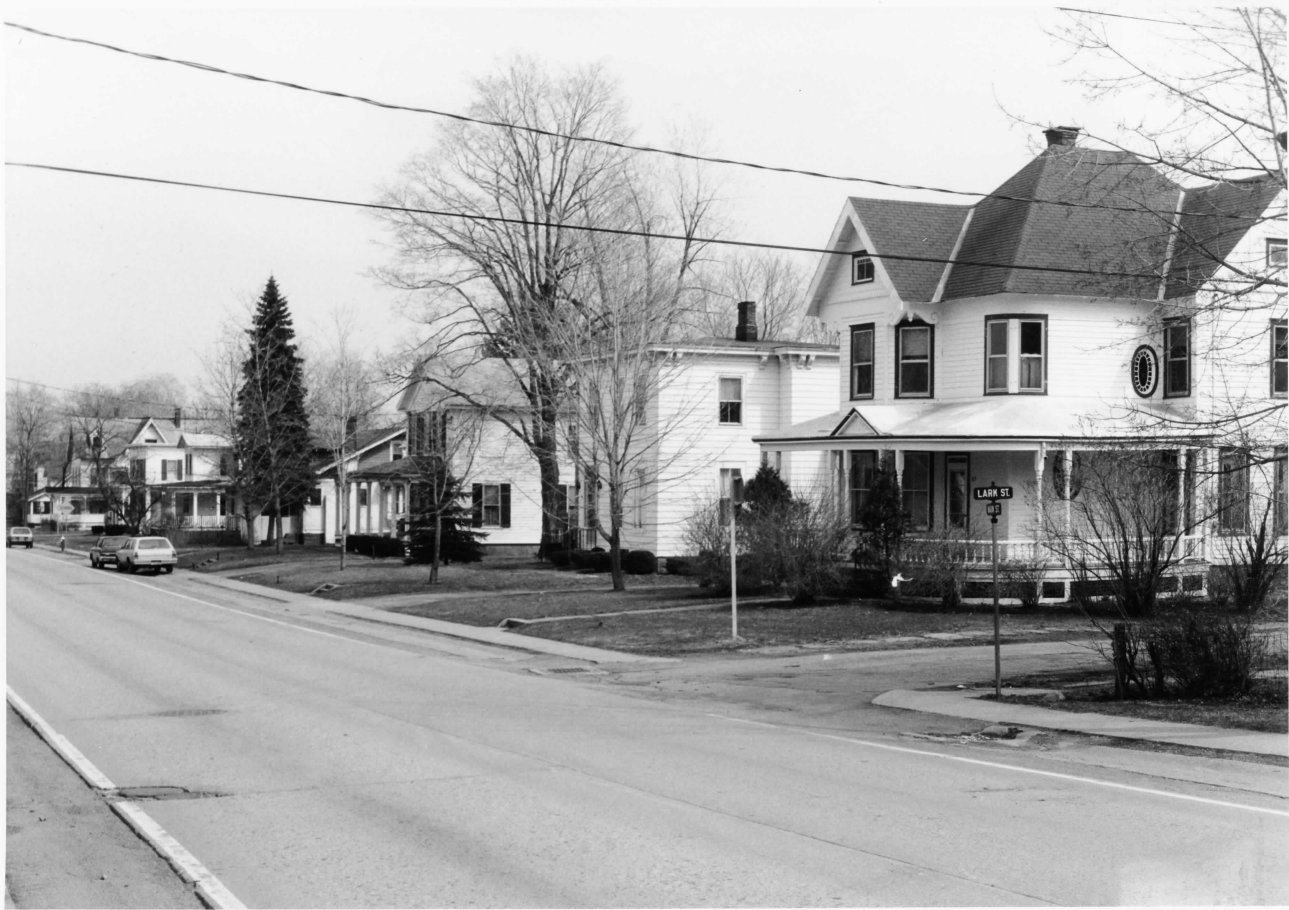
2.

View: 145-163 Main Street
South side
Looking east

| <u>Street</u> | <u>Date</u> | <u>Description</u> | <u>Photo</u> | <u>Statewide Inv.</u> <u>No.</u> |
|---|---|---|---|---|
| 159 Main St. 1863 | | Two stories, wood frame, gable roof, ell on east side, one-story porch on front, 2/2 shuttered windows, clapboard siding, three bays wide. | 2, 3 | 001-45-0035 33 |
| 161 Main St. 1872 | | Two stories, wood frame, three bays wide, bracketed cornice, aluminum siding. | 2 | 001-45-0034 34 |
| 163 Main St. 1892 | | Three and one-half stories, wood frame, hipped roof with projecting gables, clapboard siding and scalloped shingles in gable ends, one-story porch across front, Queen Anne Style design. | 2 | 001-45-0033 35 |

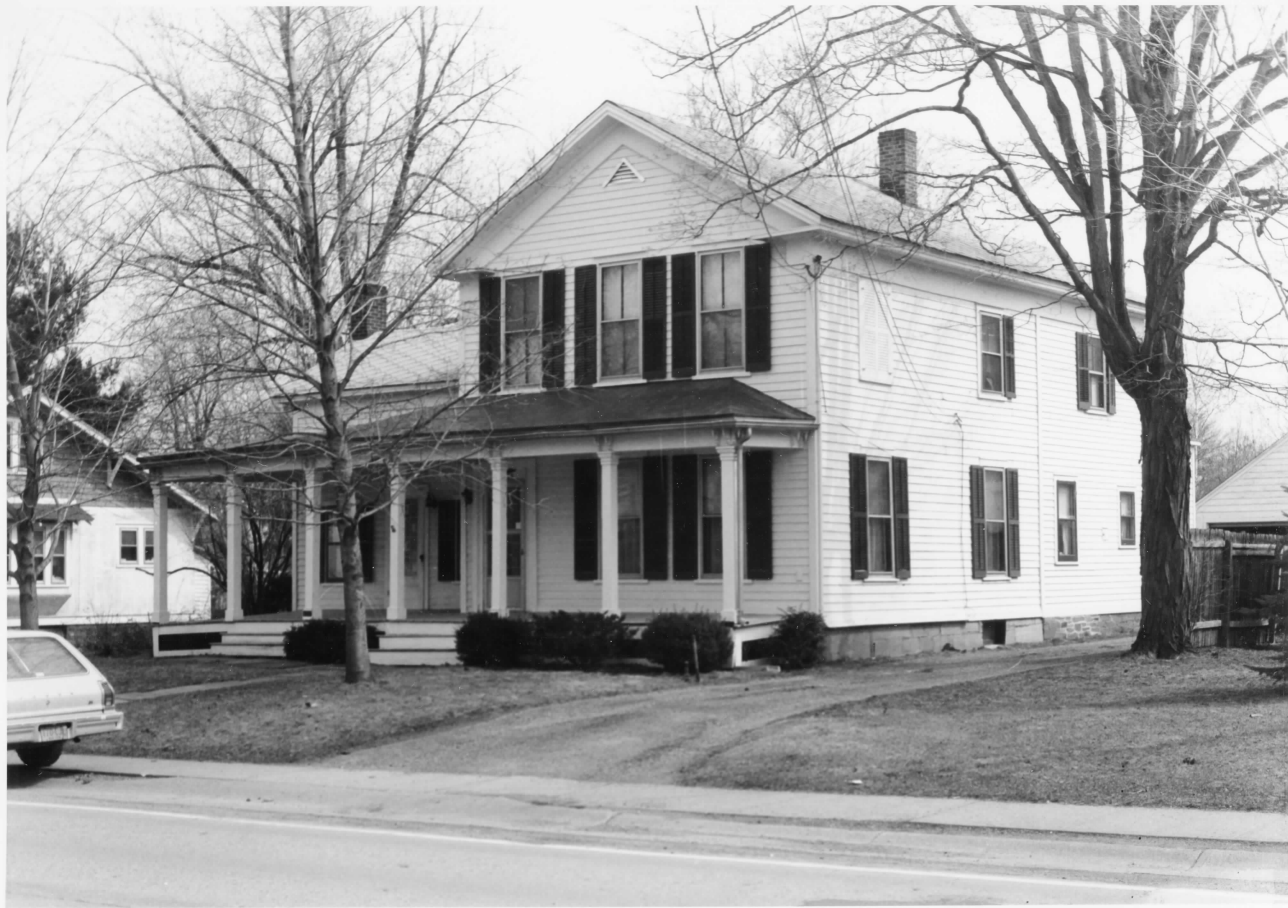
3.

View: 159 Main Street
Front elevation

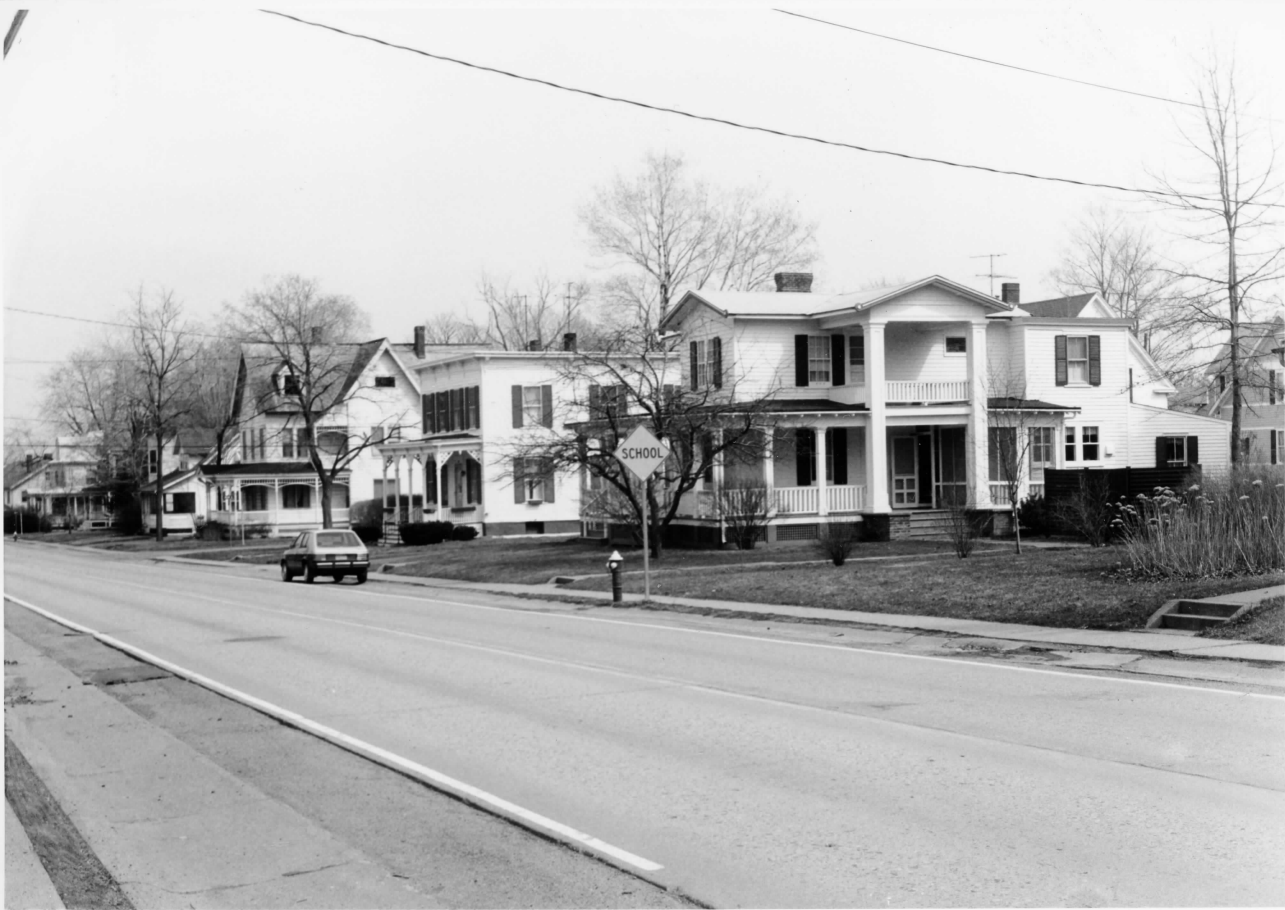
4.

View: 145-151 Main Street
South side
Looking east

| <u>Street</u> | <u>Date</u> | <u>Description</u> | <u>Photo</u> | <u>Statewide Inv.</u> <u>No.</u> |
|---|---|---|---|---|
| 145 Main St. | c.1890 | Three stories, wood frame, intersecting gable roof with dormers, one-story porch on front with pediment at entrance and decorated spandrels, aluminum siding. | 4 | 001-45-0039 29 |
| 147 Main St. | 1875 | Two stories, wood frame, flat roof, four bays wide, one-story porch across front with decorated brackets, shuttered windows; duplex. | 4, 5 | 001-45-0038 30 |
| 151 Main St. | c.1880 | Two stories, wood frame, cruciform plan, flat gable roof, large two-story portico on west side, one-story porch on three sides, addition on rear. | 4 | 001-45-0037 31 |

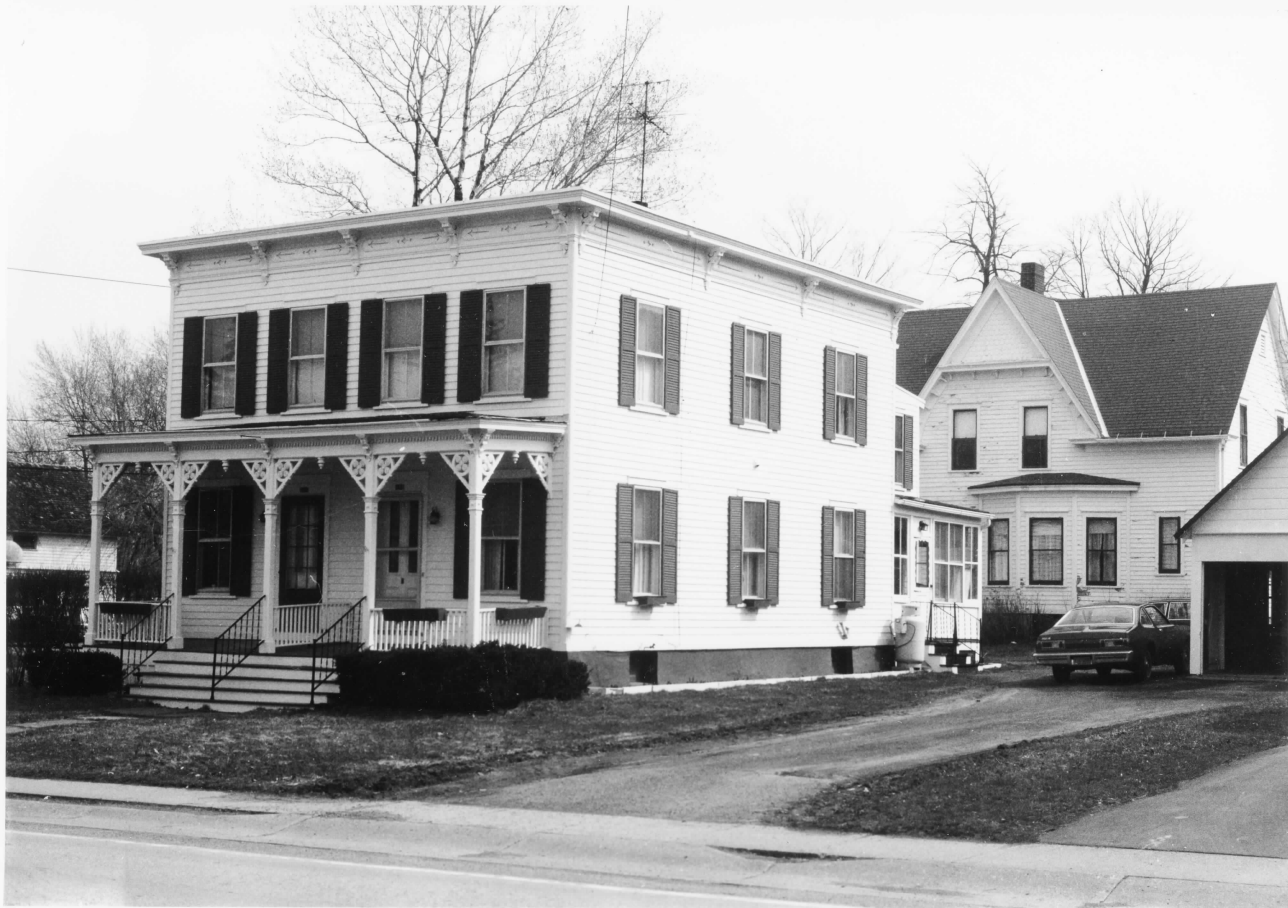
5.

View: 147/149 Main Street
Front elevation

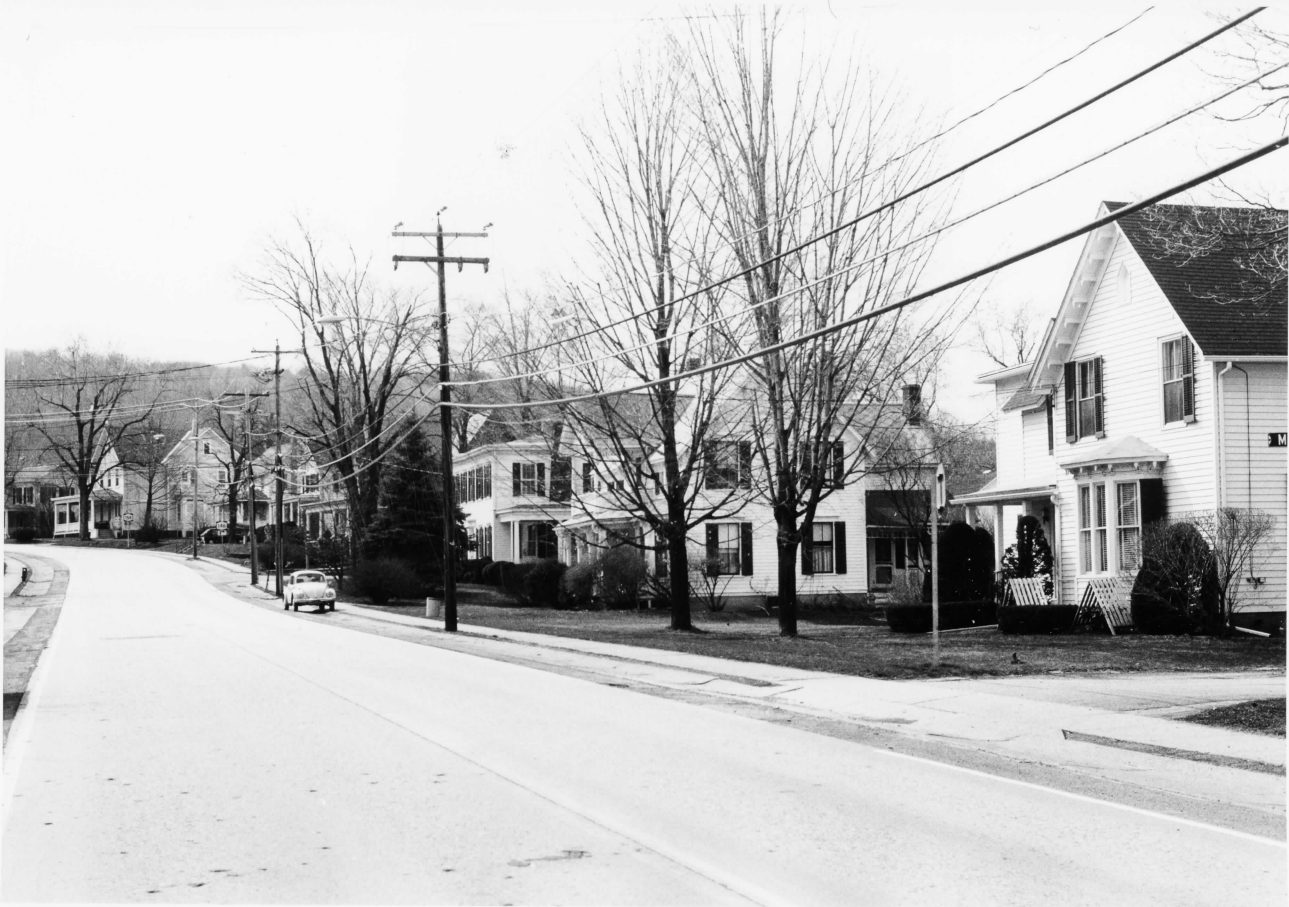
6.

View: 174-156 Main Street
North side
Looking west

| <u>Street</u> | <u>Date</u> | <u>Description</u> | <u>Photo</u> | <u>Statewide Inv.</u> <u>No.</u> |
|---|---|---|---|---|
| 156 Main St. | c.1870 | Two stories, wood frame, gable roof with dormer, L-plan, bay window on front, small one-story porch, two-story addition on west side, aluminum siding. | 6 | 001-45-0015 11 |
| 162 Main St. | 1868 | Two stories, wood frame, gable roof, clapboard siding, bracketed cornice, projecting gable crowning a two-tiered porch above center entrance, bay windows on front. | 6 | 001-45-0041 12 |

| <u>Street</u> | <u>Date</u> | <u>Description</u> | <u>Photo</u> | <u>Statewide Inv.</u> <u>No.</u> |
|---|---|---|---|---|
| 166 Main St. | 1872 | Two stories, wood frame, five bays wide, center entrance, flat roof, plain cornice and frieze, shuttered windows, porches on rear and east side, clapboard siding. | 6,7 | 001-45-0013 13 |

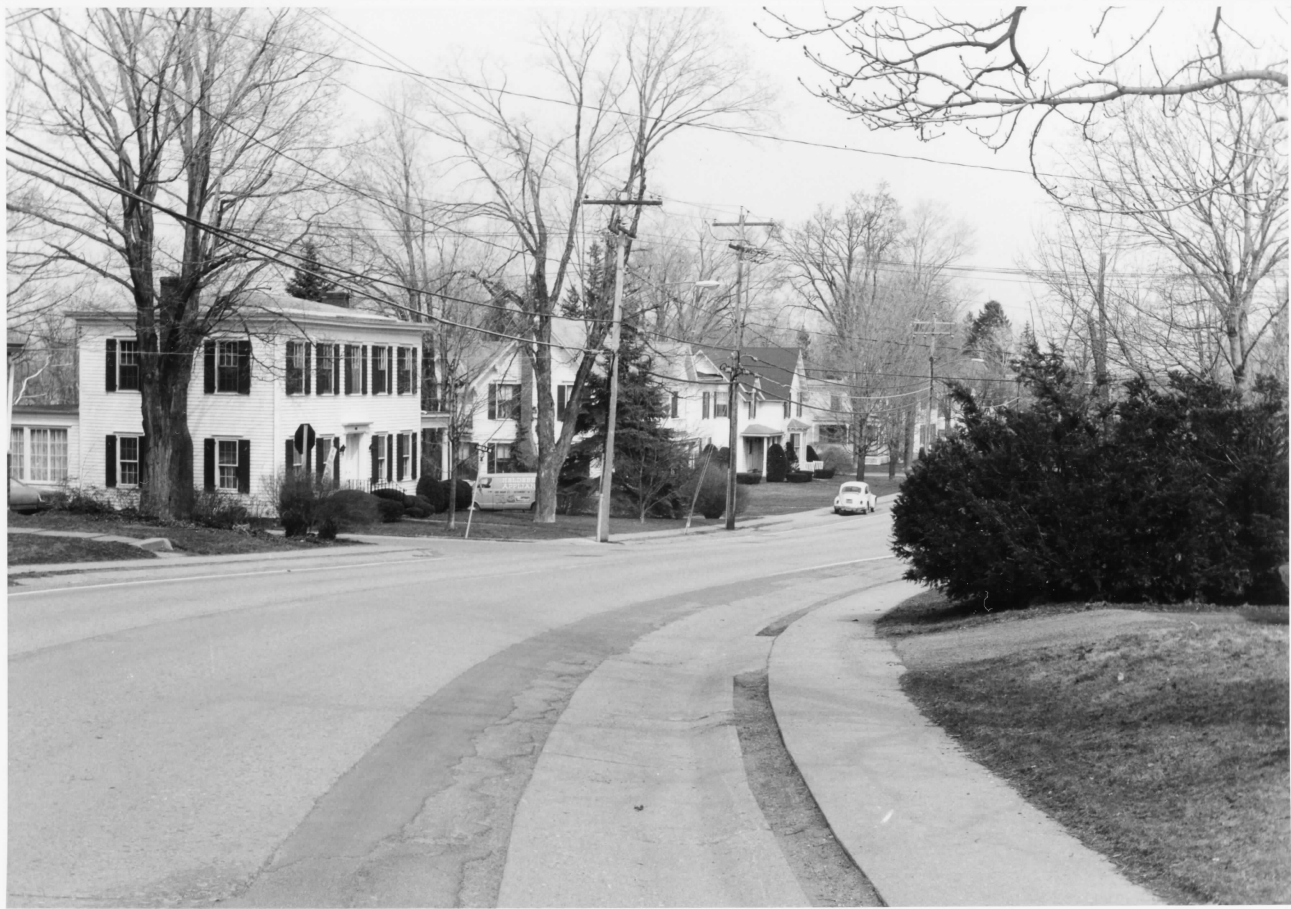
7.

View: 166-154 Main Street
North side
Looking east

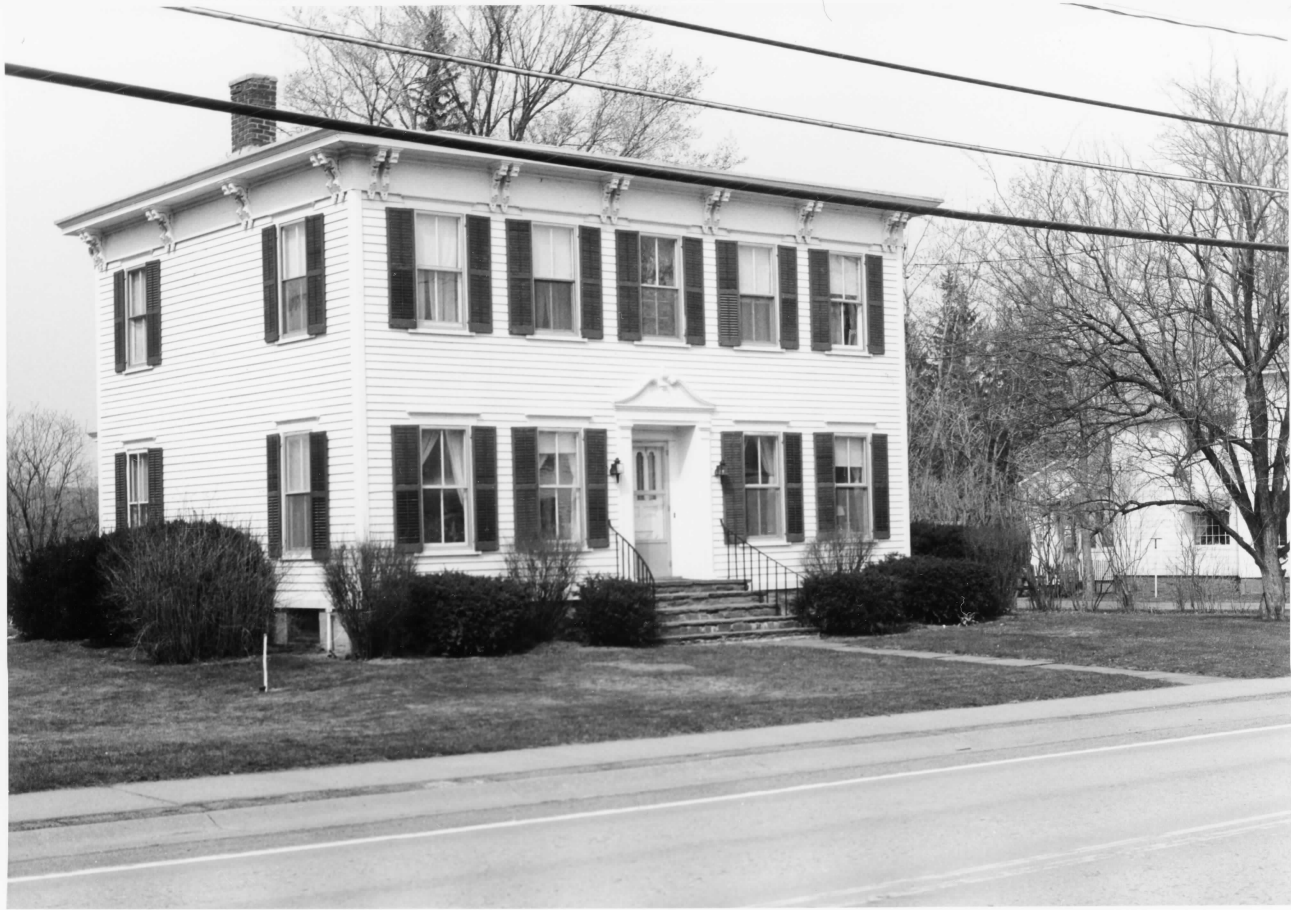
8.

View: 150 Main Street
Front elevation

| <u>Street</u> | <u>Date</u> | <u>Description</u> | <u>Photo</u> | <u>Statewide Inv.</u> <u>No.</u> |
|---|---|---|---|---|
| 150 Main St. | 1876 | Two stories, wood frame, Italianate Style design, five bays wide, bracketed cornice with wide overhang, flat roof, center recessed entrance, original porch removed, scrolled pediment over door. | 8 | 001-45-0017 9 |

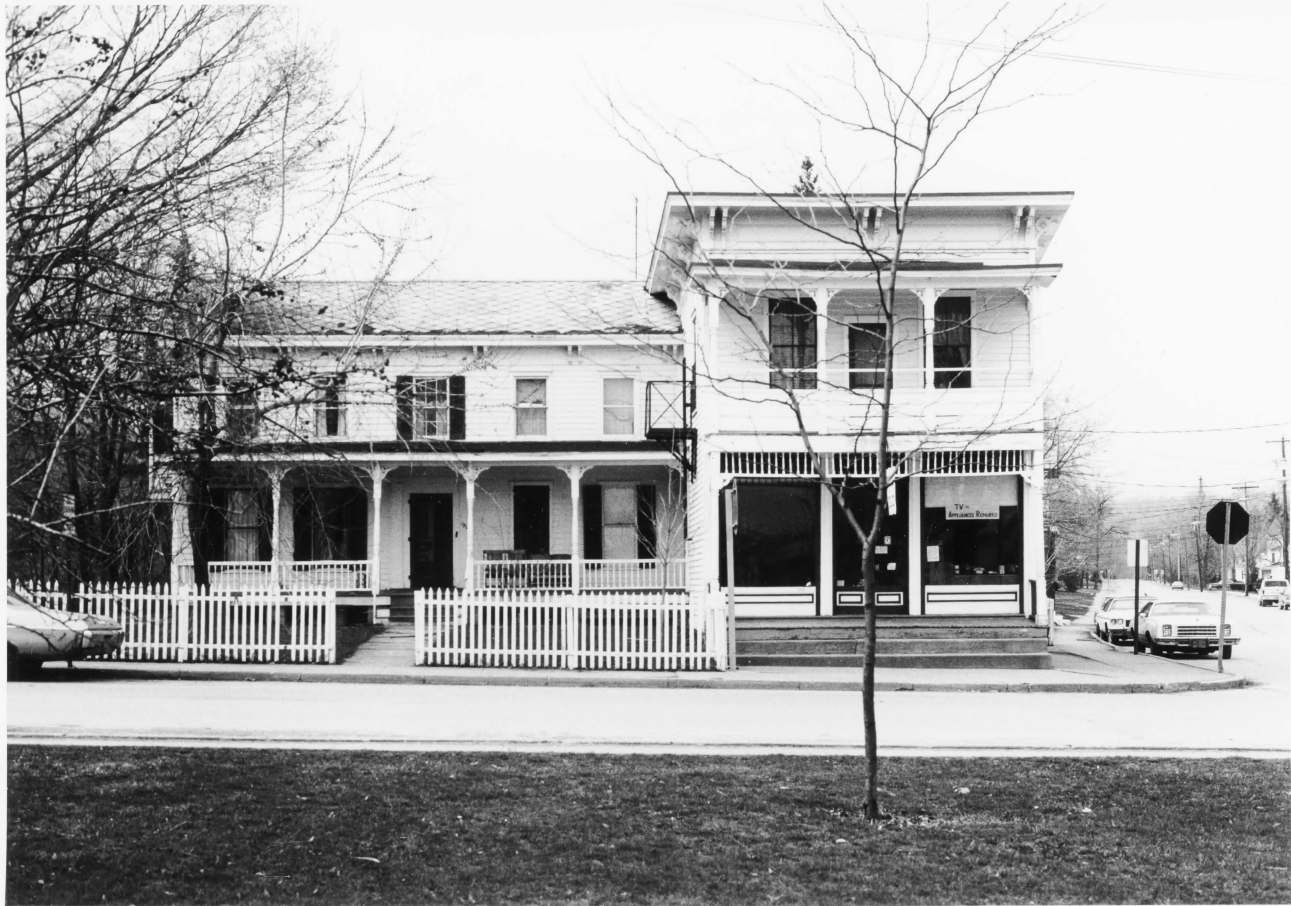
9.

View: 190 Main Street
Front elevation

| <u>Street</u> | <u>Date</u> | <u>Description</u> | <u>Photo</u> | <u>Statewide Inv.</u> |
|---|---|--|---|---|
| 190 Main St. | c.1880 | Two stories, wood frame, flat roof, two tiered porch on front with detailed paired brackets on cornice, original storefront, two-story ell on west side with gable roof and one-story porch with detail. | 9 | 001-45-0004 21 |

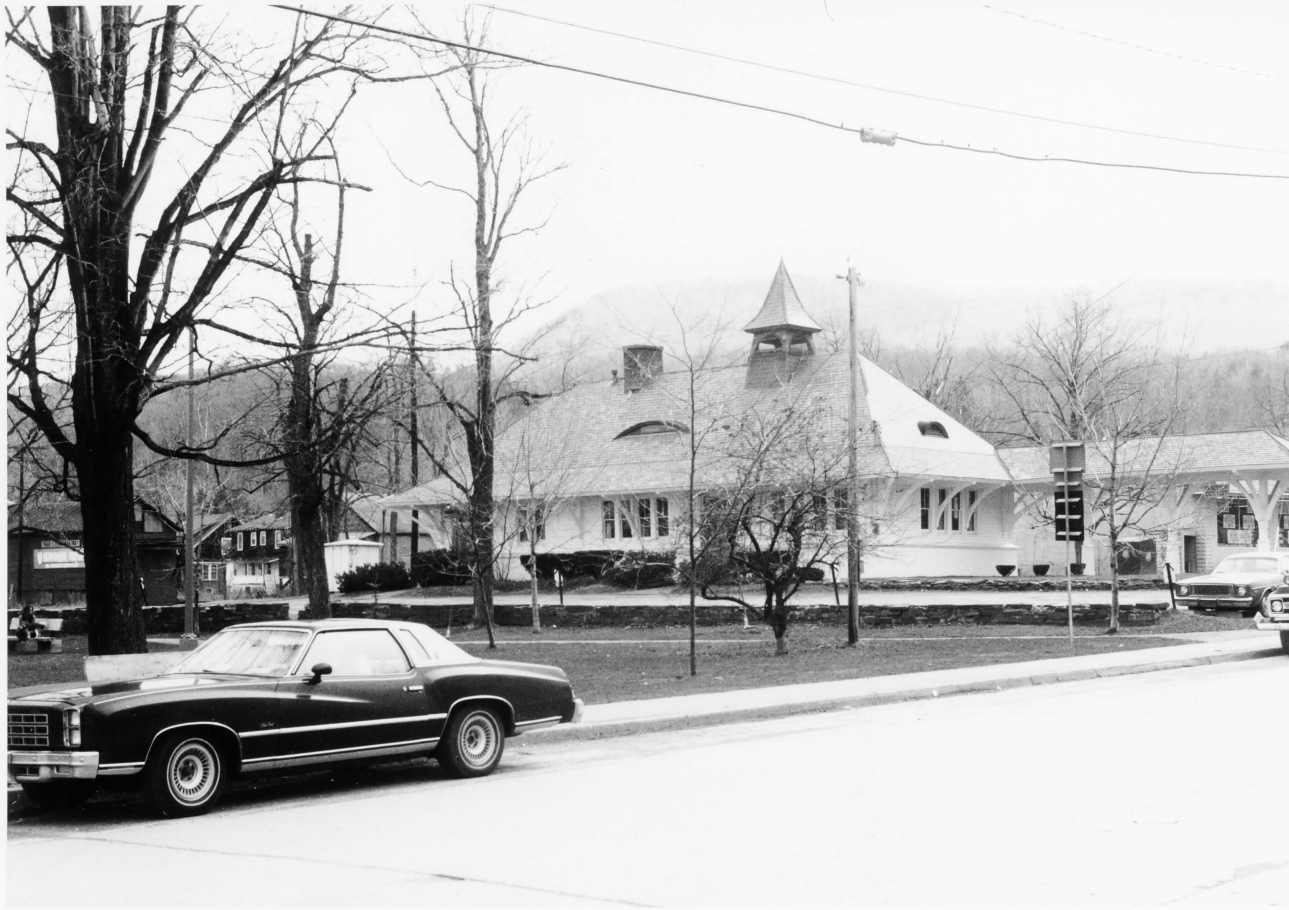
View: Old Delaware & Hudson
Railroad Station
Main Street
South side
Looking west

| <u>Street</u> | <u>Date</u> | <u>Description</u> | <u>Photo</u> | <u>Statewide Inv. No.</u> |
|---|---|--|---|---|
| Main St. at tracks | 1897 | Late nineteenth-century railroad station, listed on National Register 8-12-71, adapted for use as offices. | 11 | 001-45-0001 |
