National Register of Historic Places
Registration Form

historic name The Lainhart Farm Complex and Dutch Barn

Lainhart Farm Complex and Dutch Barn

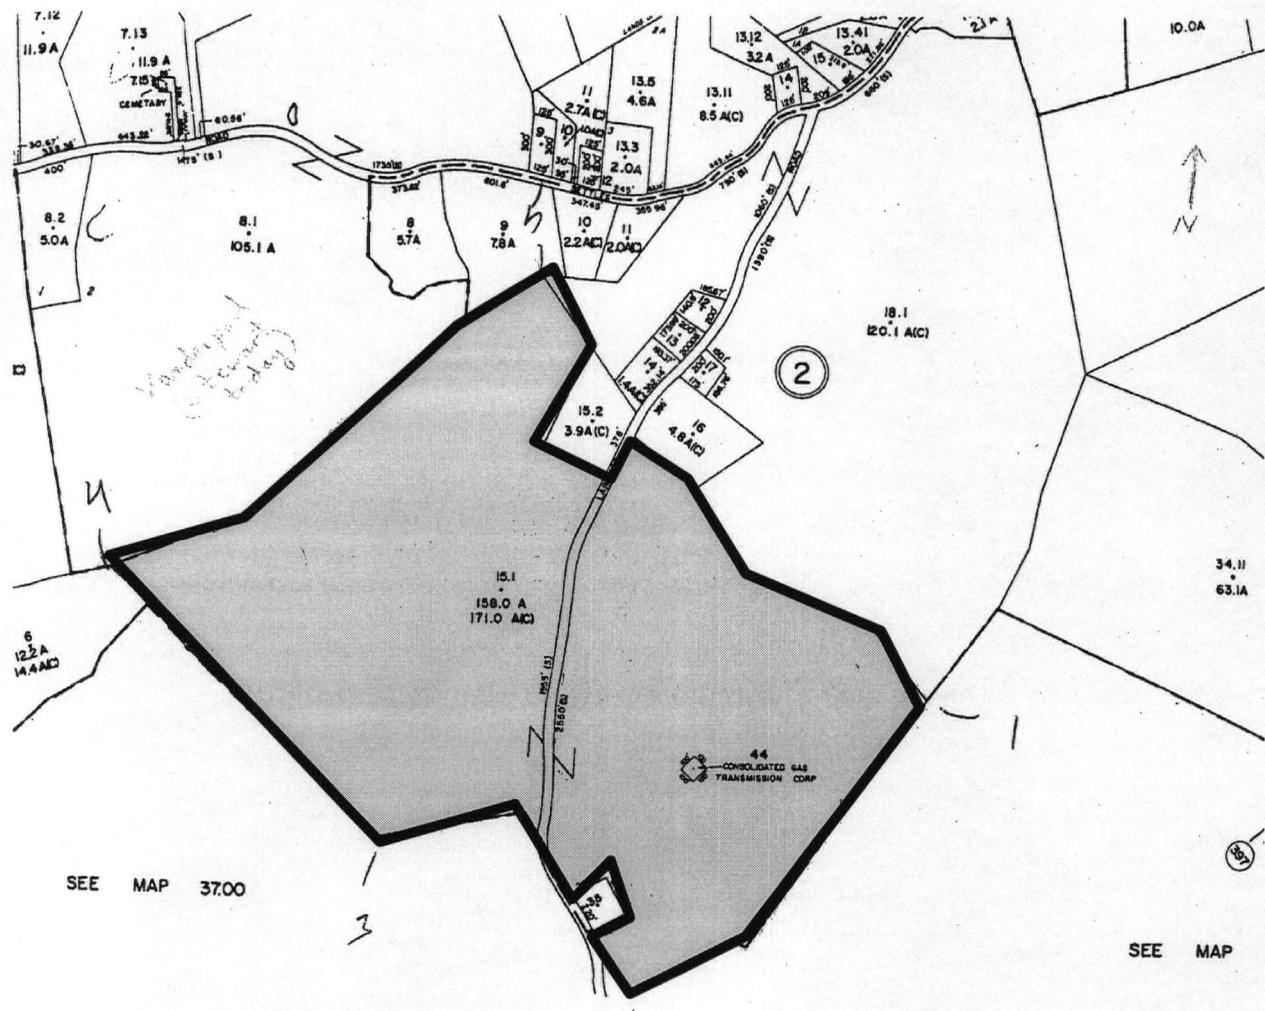
Section number MAP

The boundary for the nominated property is shown as the heavy black outline on the accompanying map entitled Lainhart Farm Complex and Dutch Barn, Guilderland, Albany County, New York.

scale 1 inch equals 1050 feet
boundary
photo key

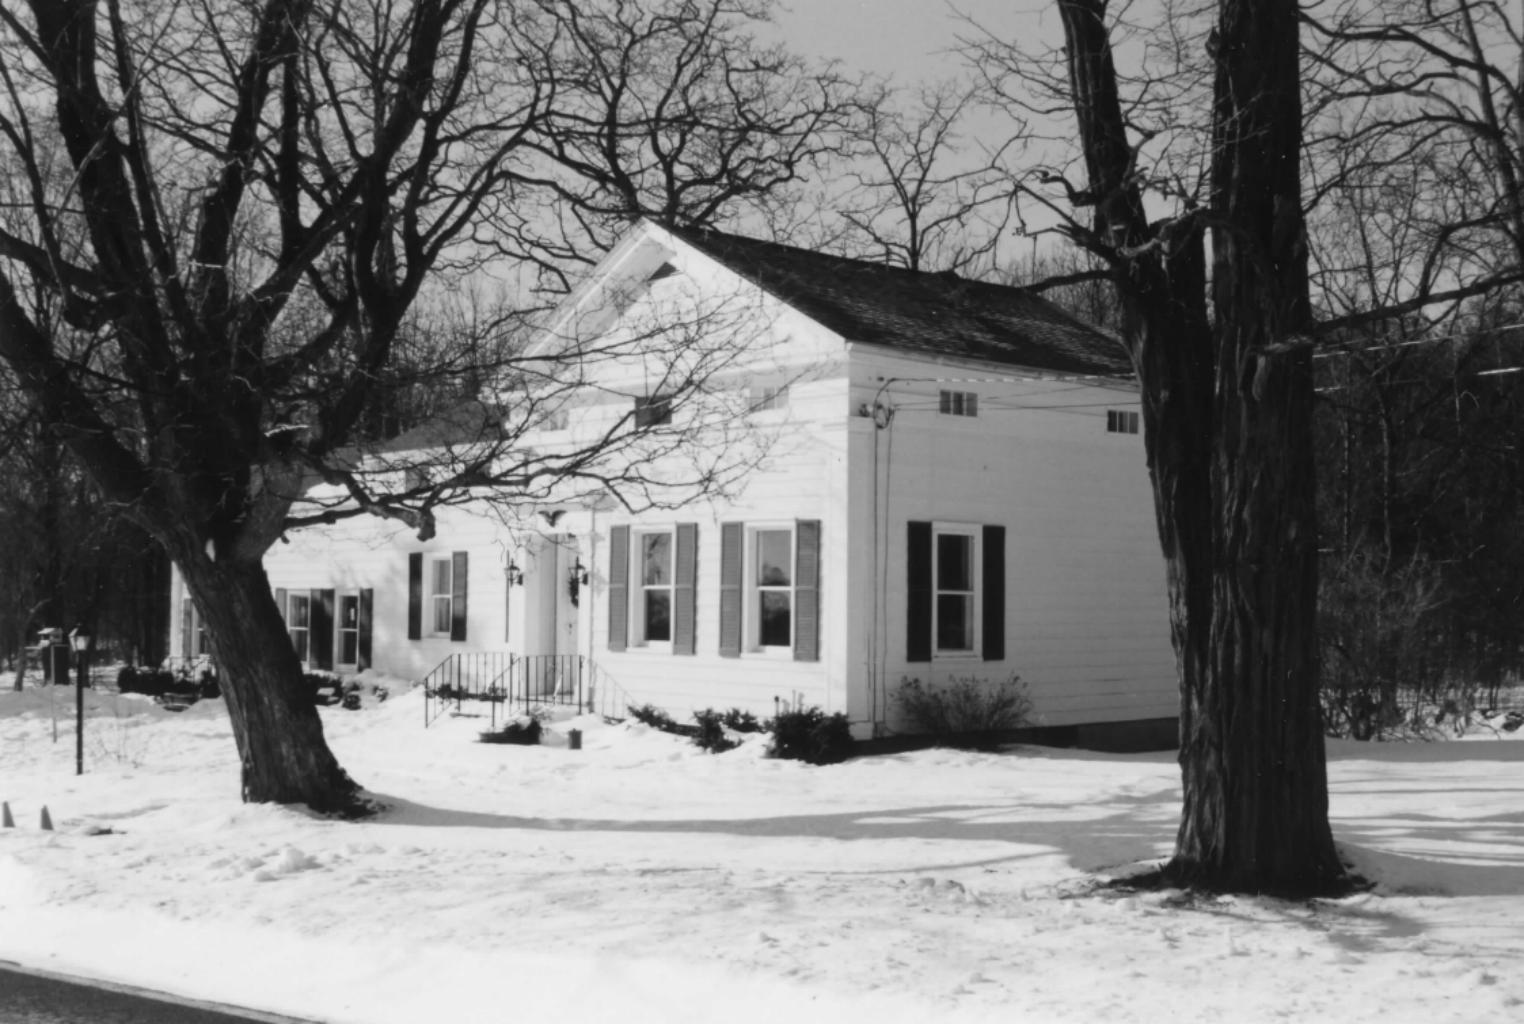
1

1. Farmhouse, east façade and north elevation
2. Interior detail
3. Interior detail
4. West elevation of Dutch Barn (horse barn to the right)
5. Dutch barn, east elevation (note farmhouse to the left)
6. Interior frame detail of Dutch barn
7. Interior frame detail of Dutch barn
8. Interior frame detail of Dutch barn
9. East elevation of horse barn, south elevation of the Dutch barn
10. East elevation of wagon house, cemetery on rise of land to the right of barn
11. Cemetery detail
12. Cemetery detail
13. Cemetery detail
14. Cemetery detail
15. Original copy of the indenture

The Lainhart farmhouse is at least the second home to be constructed on the farm. The house appears to date from the 1850s. The house is a two story, timber framed, gabled-L, Greek Revival building. The main block, wing and wing extensions are covered by gable roofs sheathed with asphalt shingles. The building is sheathed with clapboards. The east elevation of the main block forms the architectural focal point of the building. The gable fronted façade is highlighted by wide corner boards and a finely crafted Greek Revival style entryway.
